## **5.1 CAPITAL WORK**

### **5.2 PIPING**

## 1Q/2007 4CU "Major" S/D - DED Post Mortem

## **5.3 COLUMNS / VESSELS**

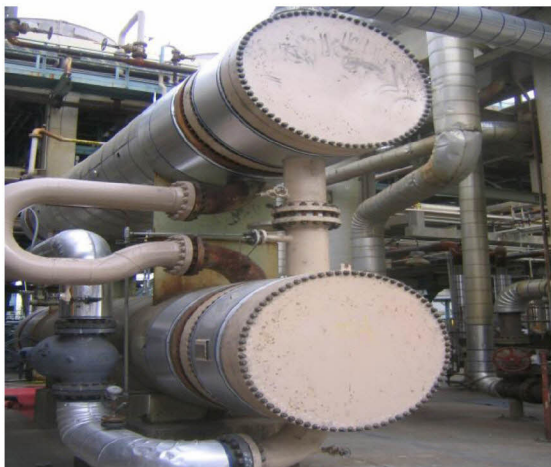
Replaced channel with redesign. Channel and cover clad with 304L, and nozzles overlayed with 309L. Redesign eliminates the interconnecting spool piece, and connects channels A and B directly. The interconnecting spool between the channels had historically seen high corrosion rates.

**Fig 5.1.3:** E-825A/B Channels. 304L Clad and redesigned to have directly connected channels, eliminating the funky interconnecting spool (see the shellside spool).

Replaced channel with redesign. Channel and cover clad with 304L, and nozzles overlayed with 309L. Redesign eliminates the interconnecting spool piece, and connects channels A and B directly.

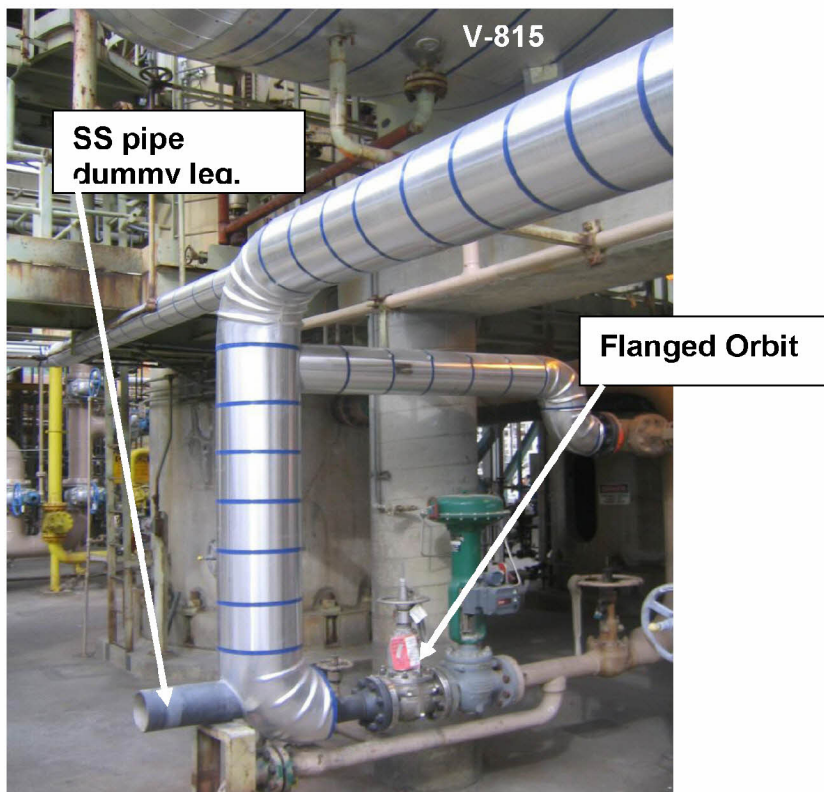
Upgraded approximately 60 linear feet of 8" CS piping (old pipe class, AF9) from LCV-811 to V-815 with 304L SS piping (new pipe class, GF6 without stress relief!). Had to use a short radius elbow immediately downstream of LCV-811 to accommodate the flanged orbit valve that was ordered instead of the appropriate weld-end valve (The purchasing culprit shall remain nameless.). Existing pipe supports were structural beams, but these were not purchased in the stainless variety, so SS pipe dummy legs were used.

**Fig 5.1.5a:** Stainless steel piping from LCV-811 to V-815.

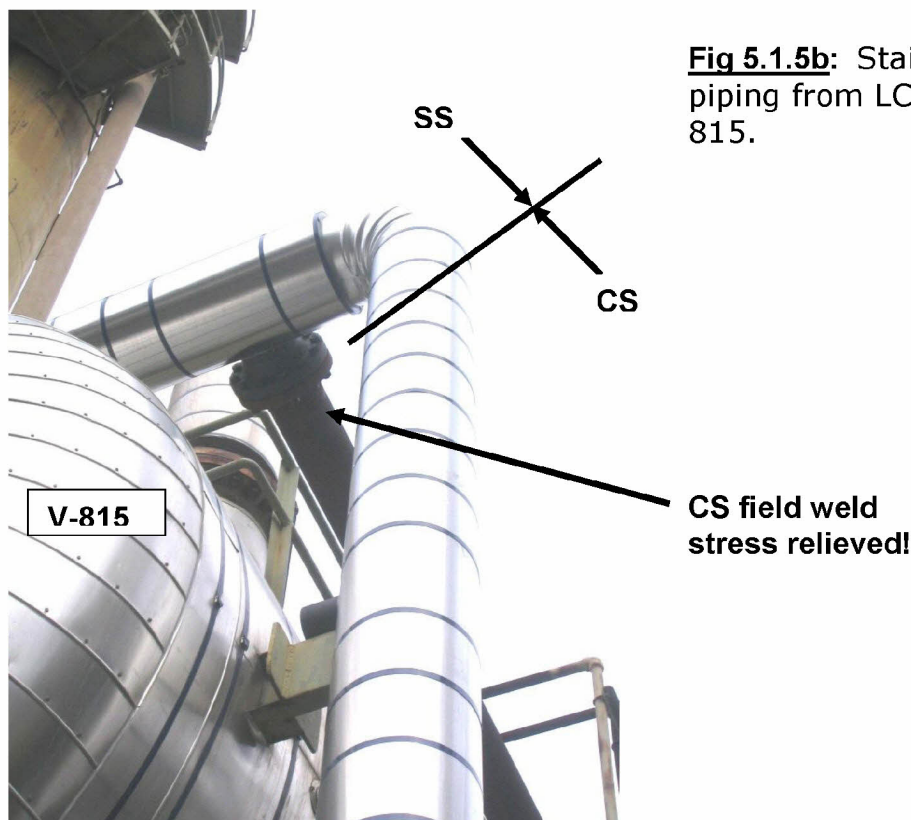
The weld on the 8" CS flange that was added on the incoming line from C-860 was stress relieved at 1200F for 1 hour, as required by Rich DEA service above 140F.

**Fig 5.1.5b:** Stainless steel piping from LCV-811 to V-815.

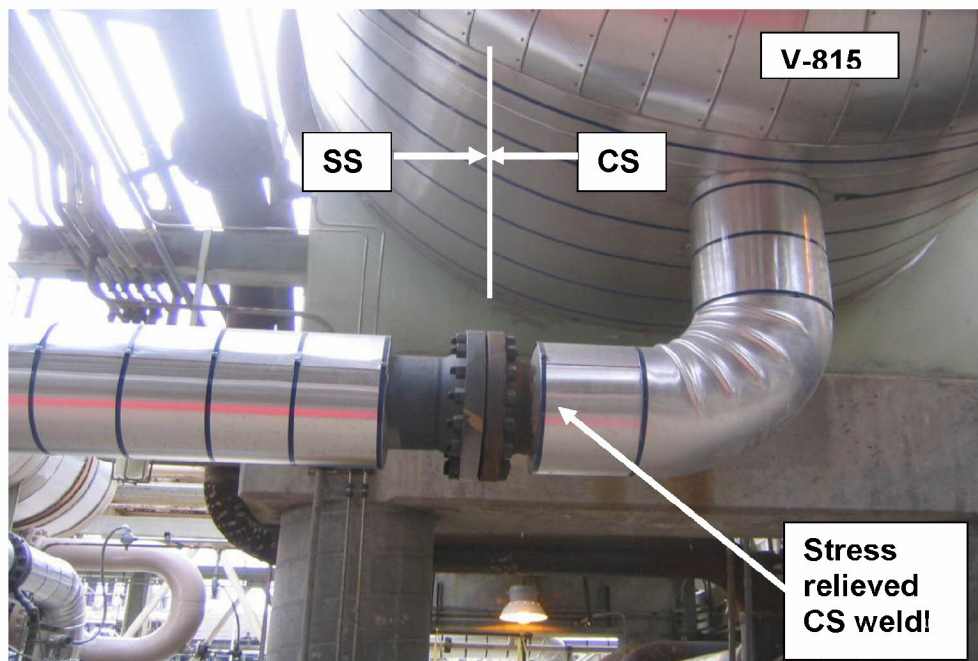
**Fig 2.1.6:** Carbon steel piping to consider replacing next S/D. Possibly replace with SS back to the vessel stub next opportunity - CS weld will require stress relief.

Revisit, and decide on whether or not replace the remaining 10" CS piping all the way to the V-815 stub. CS weld at the vessel stub will require stress relief. If the CS is not replaced, it will require UT to ensure that there is enough metal for another 5 year run.

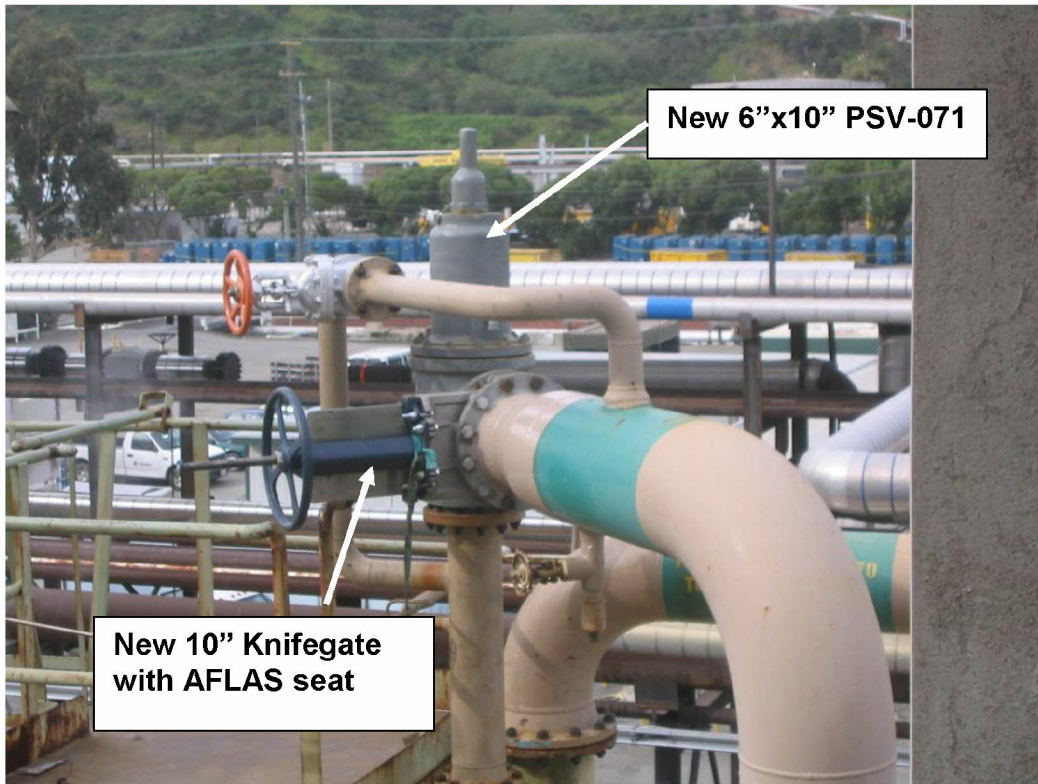
Per the D&R Relief Study, PSV-071 was undersized, and needed to be upsized from a 6" x 8" to a 6" x 10". The associated outlet piping and isolation Knife Gate immediately downstream of the PSV had to be replaced as well. The new 10" Knife Gate is 304SS with AFLAS Flouroelastomer seat, and Teflon Graphite Packing.

**Fig 5.1.10:** New upsized PSV on V-870 with new 10" Knife Gate Valve.

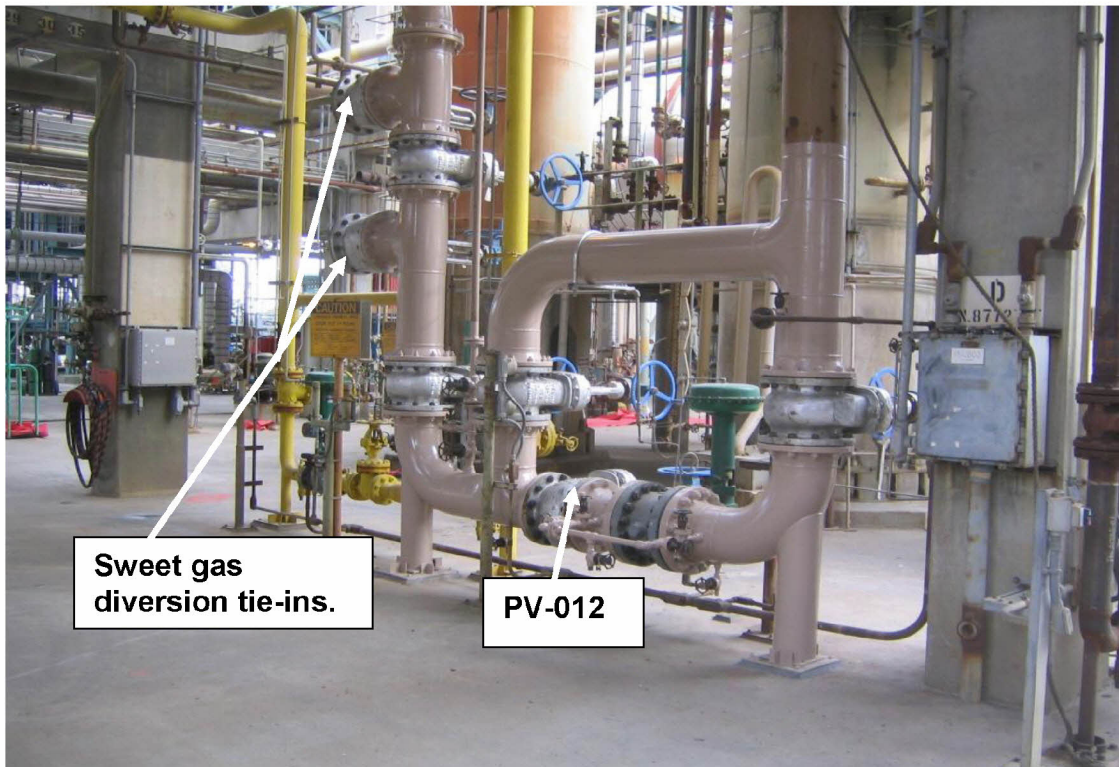
Added a new spool with two 12" connections and an intermediate block valve just downstream of PV-012, to allow for the future diversion of sweet gas to the SMR, and process gas return from PSA3.

**Fig 5.1.15a:** New sweet gas tie-ins for SMR, downstream of newly upsized PV-012. Isn't that a nice paint job!

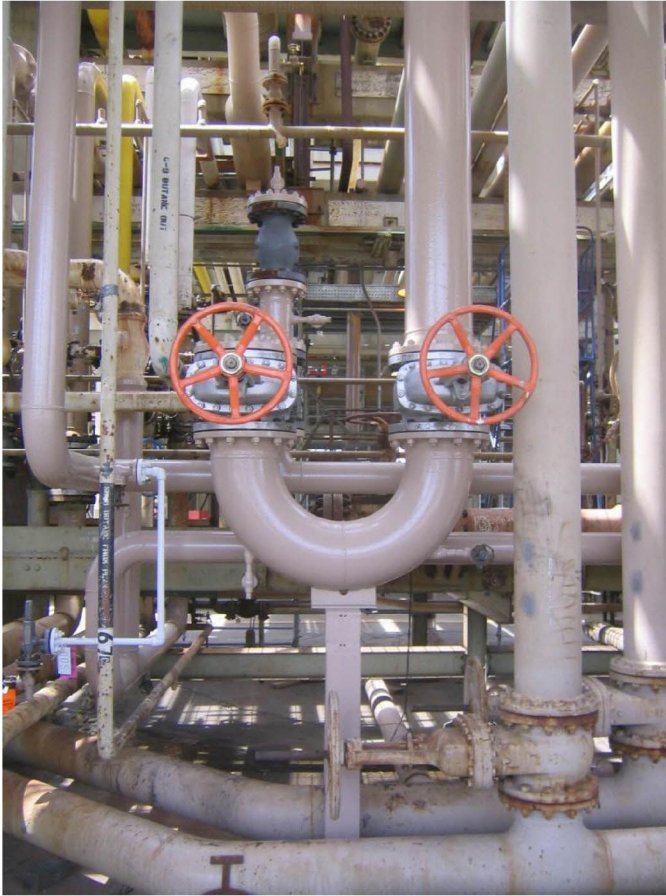
Added 12" connection at the plot limit for the future Process Gas Balance Line. This is the big 12" U at the plot limit (see fig 5.1.15b).

**Fig 5.1.15b:** New 12" tie-in at the plot limit for the future Process Gas Balance Line.

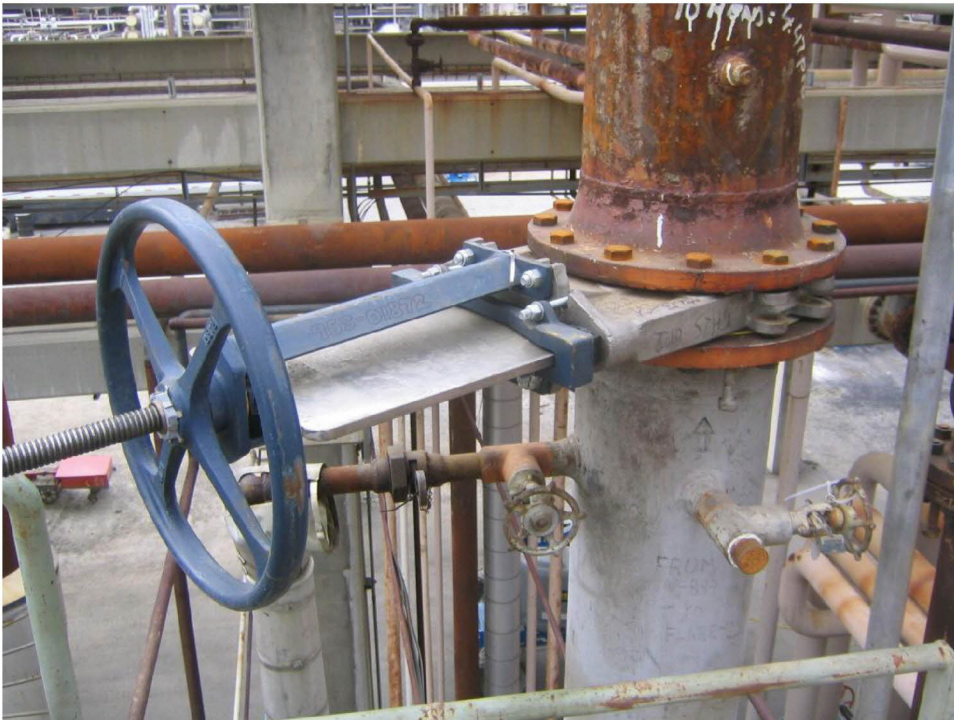
This is a 14" Fabri-Valve Knife Gate. The job was originally planned as a fresh-air swap out, but that idea was canned last minute due to safety concerns. Ops and Maintenance Management did not want to perform "live relief" job with a 14" valve (Live relief jobs are generally limited to 2" and below.). Instead, the job was completed using an awesome 14" Freeze Plug to isolate the job from relief (Ref S/D EWO BK102-E4 Rev.0, compliments of Design Engineer Pat Murphy.). The new valve is 304SS with AFLAS Flouroelastomer seat, and Teflon Graphite Packing.

**Fig 5.2.1:** New 5H2S Relief Isolation Valve at the plot limit.

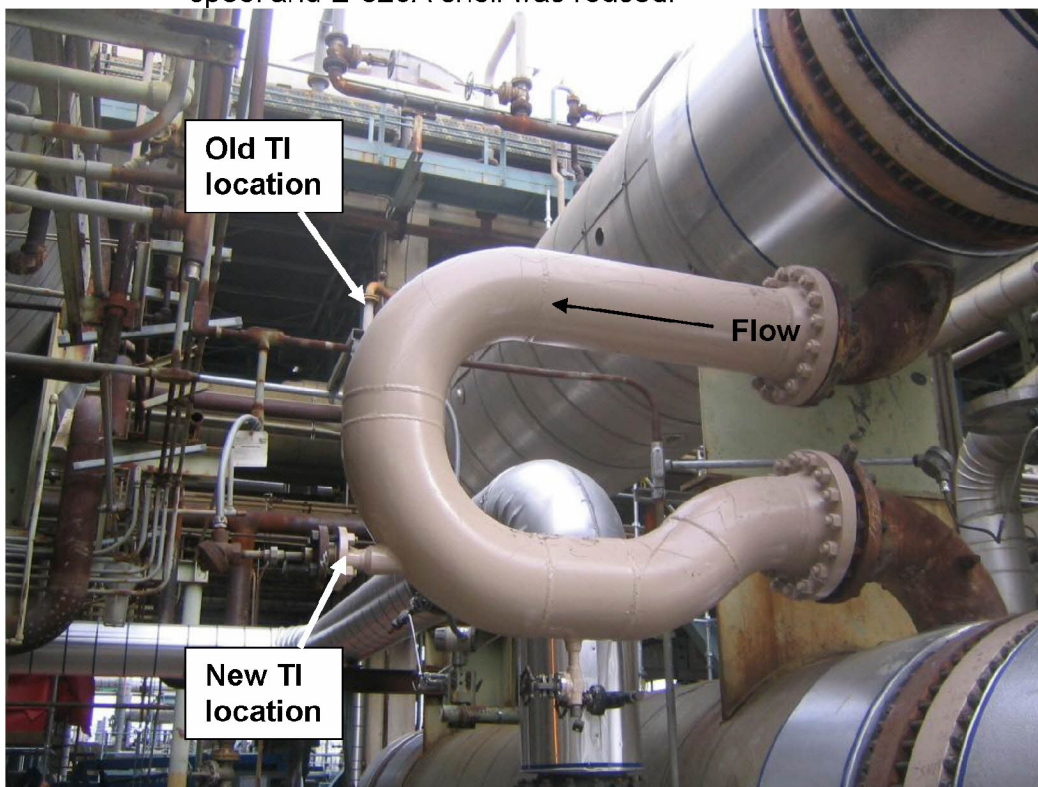
Replaced about 10" shellside interconnecting spool with 304L SS upgrade. The SS spool was actually made for the E-825 channels, but they were redesigned to be connected directly. The thermowell location on the new spool is incorrect (as it was made for the channels), so the flow is away from the TI, instead of towards it, but this was acceptable to the process folks. The CS spacer between the spool and E-825A shell was reused.

**Fig 5.2.8:** New 304L SS shellside interconnecting spool on E-825's. The spool was designed for the channels, so the TI is not exactly where we'd like it, but that's what we've got.

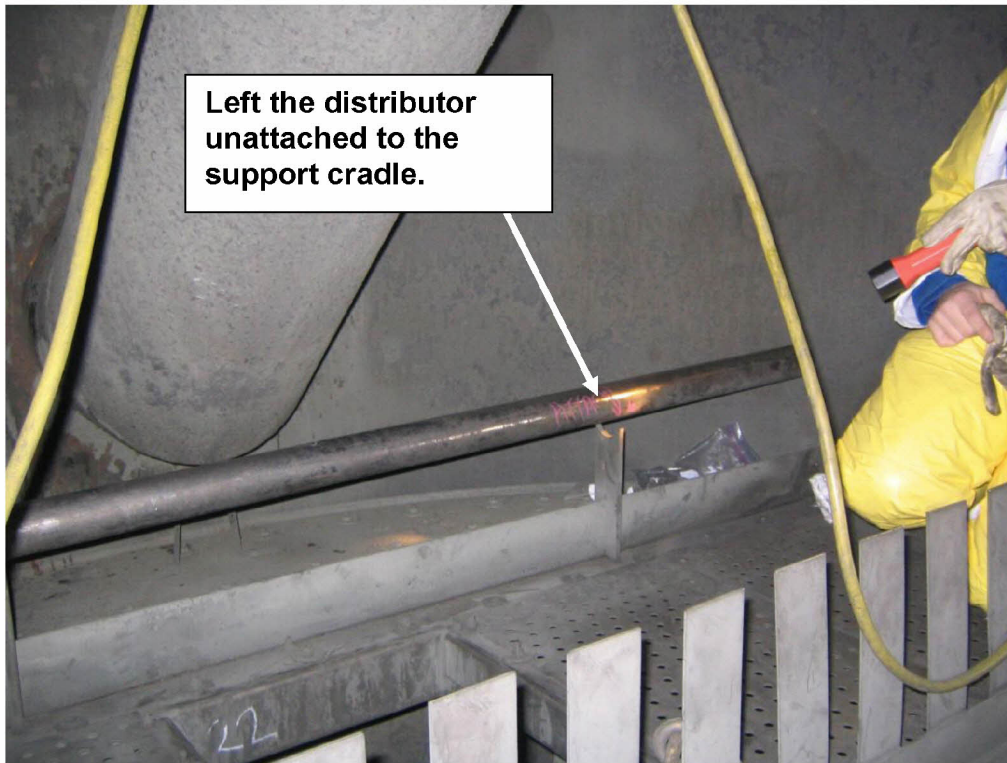
**Fig 5.3.2:** C-820 reflux distributor floating off of one of the support cradles. We decided that we were OK with that.

Inspect the reflux distributor to make sure that it is still in good repair, and possibly reattach to support cradle if needed.

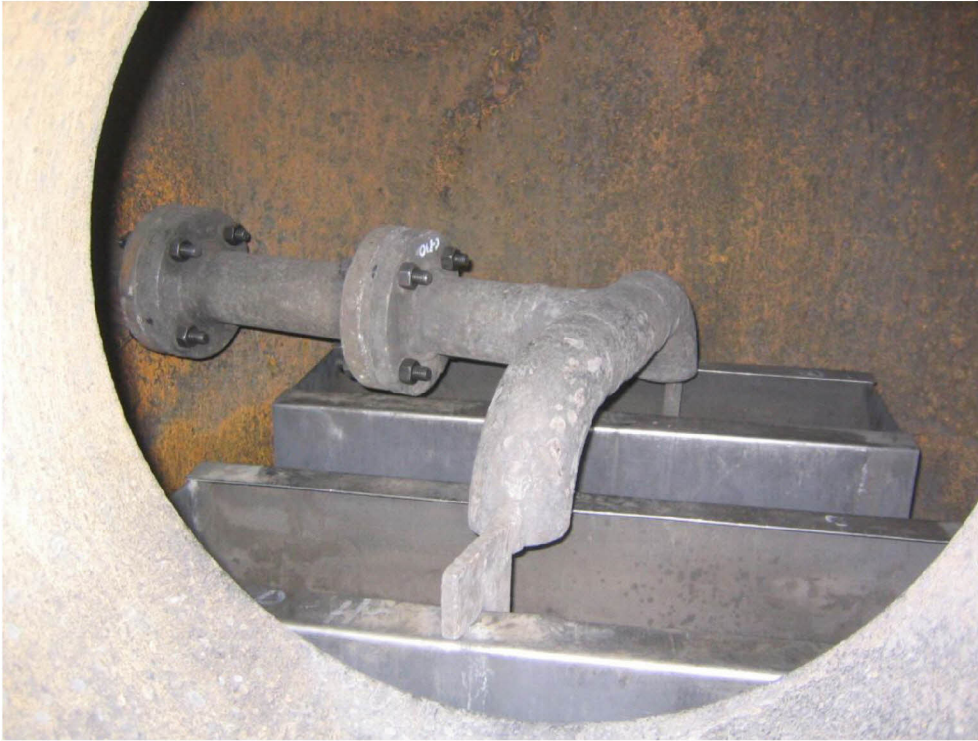
**Fig 5.3.3a:** C-830 liquid inlet distributor and wier trough distributors at S6. Ron would disapprove of the single nuts, but that's how it was for the last 10 years, and it held up just fine – the nuts get a layer of scale deposited on them anyway, so they aren't going anywhere.

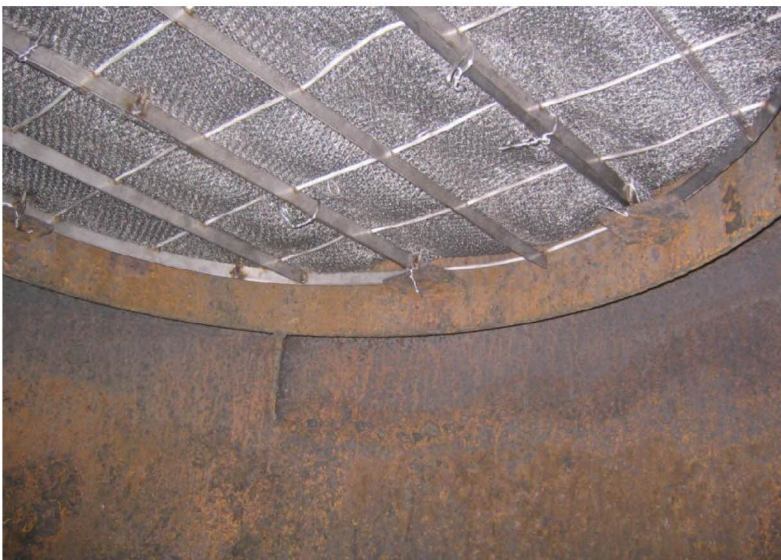
**Fig 5.3.3b:** New demister pad installed in C-830. Viewed from M5.

**Dimister Pad:** Replaced with new pad per M/R 202956.

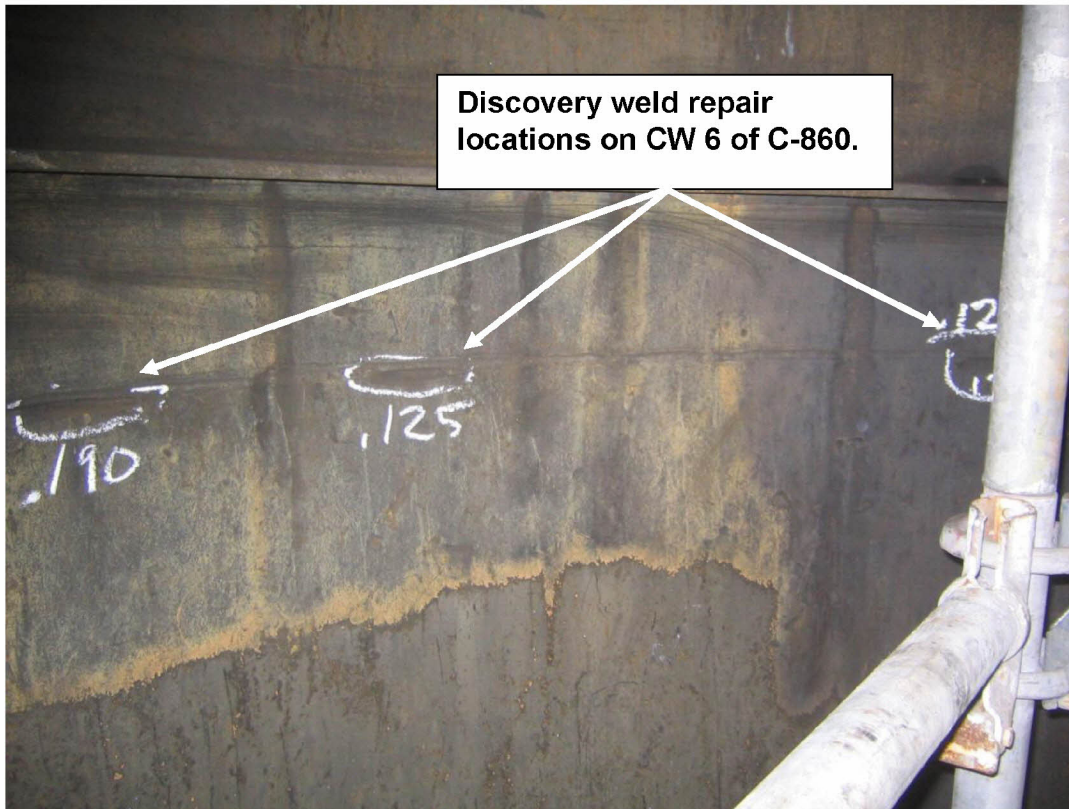
Weld repaired a total of 5 locally thinned areas on the shell of the column. There was one planned weld build at M2 (ref S/D EWO BK305-E3 Rev.1), and four other discovery weld build locations - one on circumferential weld 4, and three on circumferential weld 6 (ref S/D EWO BK305-E4 Rev.0). All weld builds required Hydrogen Bakeout at 450F min to 600F max for a minimum of four hours, and full circumferential band PWHT at 1150F for a minimum of one hour. At the current corrosion rate, two of the locations on circumferential weld 6 could have made a 10 year run, but because we had to stress relieve the entire circumferential band anyway, we went ahead and repaired them as well.

**Fig 2.3.5a:** Three discovery weld repair areas on circumferential weld 6. At current corrosion rates, the 0.125" deep indications could have made a 10 year run, but since we had to stress relieve the entire circumferential band anyway, we just went ahead and repaired them as well.

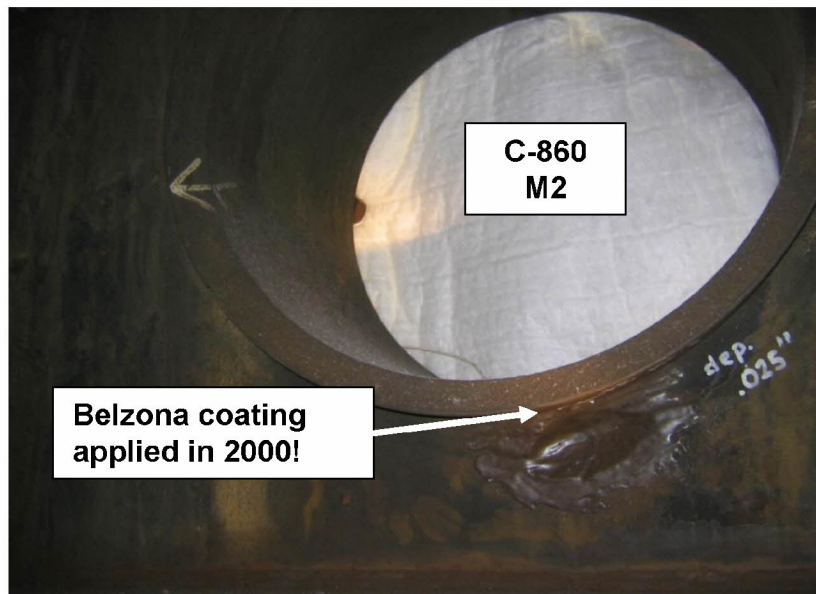
The planned weld repair (BK305-E3 Rev.1) was done at a locally thinned area identified in 2000, at which time it was coated with Belzona 1591, and a Fitness For Service (FFS) evaluation was completed. The Belzona coating held up extremely well (see Fig 2.3.5b).

**Fig 2.3.5c:** Belzona coating on FFS area under M2 on C-860 held up remarkably well for 6 years. The coating was ground out, and the shell was weld repaired this shutdown.

Consider Belzona 1591 as a possible alternative contingency plan to weld build/stress relief next time – use the fact that the Belzona applied to the FFS location under M2 held up extremely well for 6 years as support for this plan of action.

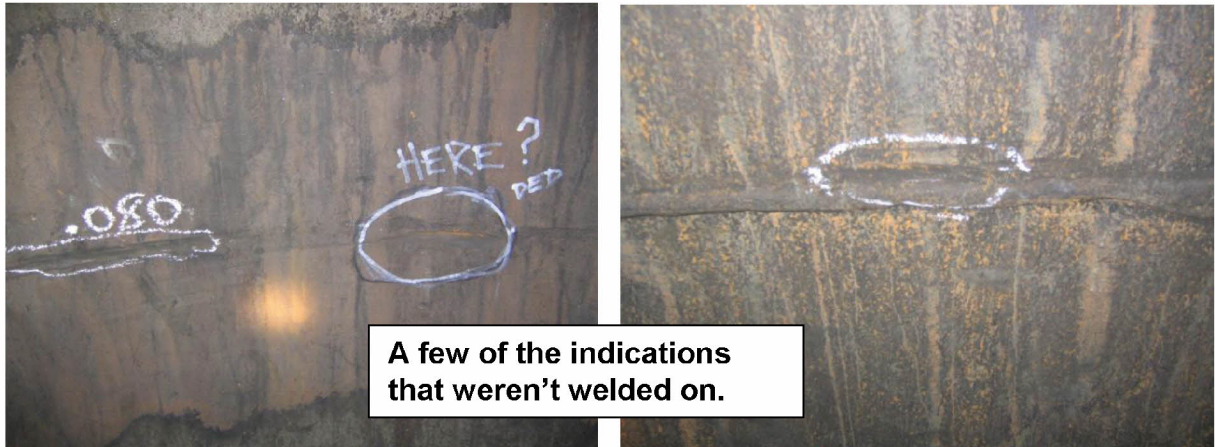
In addition to the 5 locations that were repaired this time around, there were other indications that were not addressed this shutdown. We determined that these indications could make a 10 year run, and they didn't happen to be at elevations coinciding with a mandatory repair (i.e. there are 3 indications at CW 5 that weren't welded on this time).

**Fig 5.3.5c:** There were several indications that were not addressed this shutdown, as it was determined that they could make a 10 year run. Have a contingency plan to possibly make some repairs the next time the column is entered.

Be prepared to weld build/stress relieve due to stress corrosion cracking at the welds in the column. There were several indications (3 at circumferential weld 5, for instance) that were not repaired this time around. Refer to EWO's BK305-E3 and E4 for details concerning stress relief and preparing the column for thermal growth.

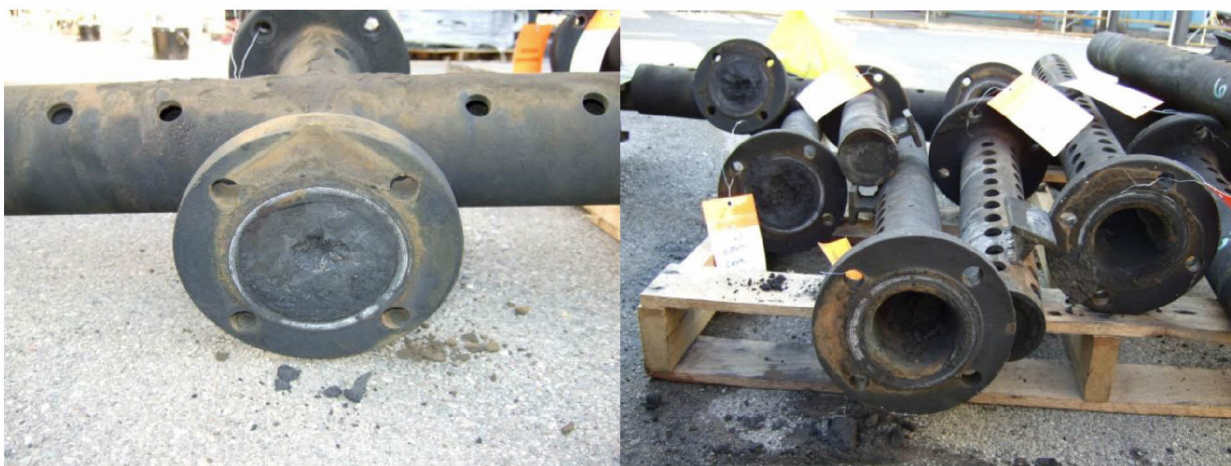
**Fig 5.3.5d:** Severely plugged sour butane inlet distributor (at S3) was removed and unplugged/cleaned.

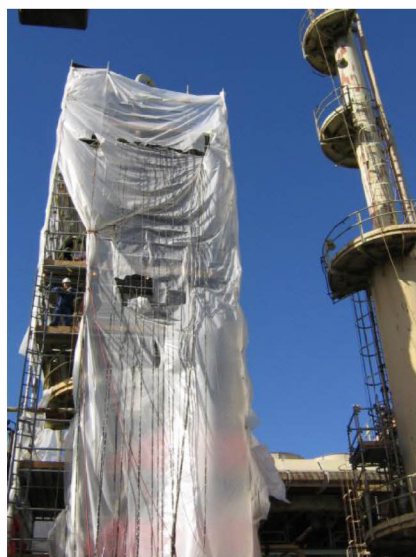
**Fig 5.3.5e:** What to expect if weld build is required - all kinds of fun!
